Table 1. Characteristics of climate stations in the vicinity of Grand Canyon National Park

METHODS

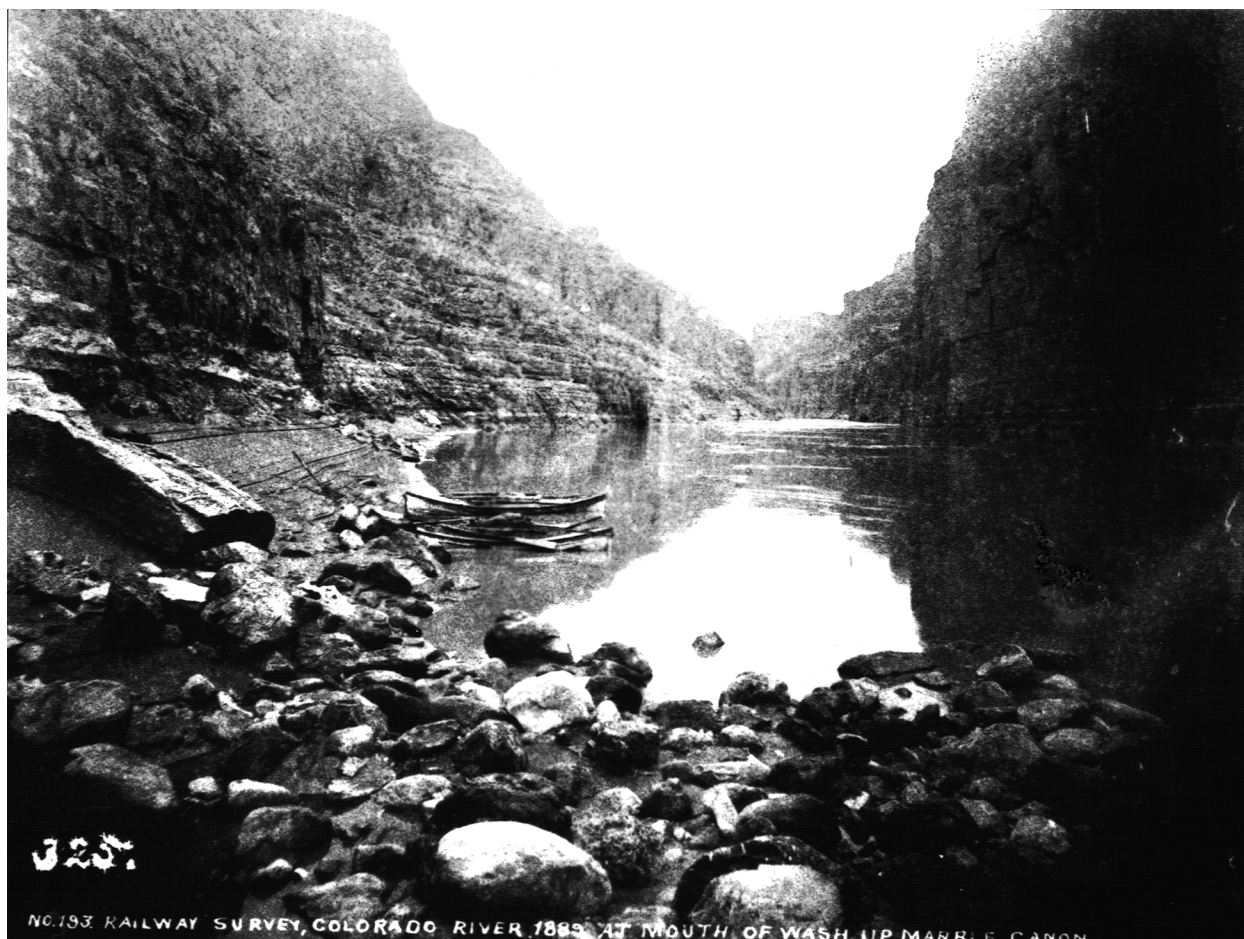
Figure 4. Replicate photographs of the debris fan at South Canyon (river mile 32.5-R). A. Photograph taken in July 17, 1889 by Franklin A. Nims. The debris fan is relatively small, and boats were parked relatively close to the mouth of the canyon.

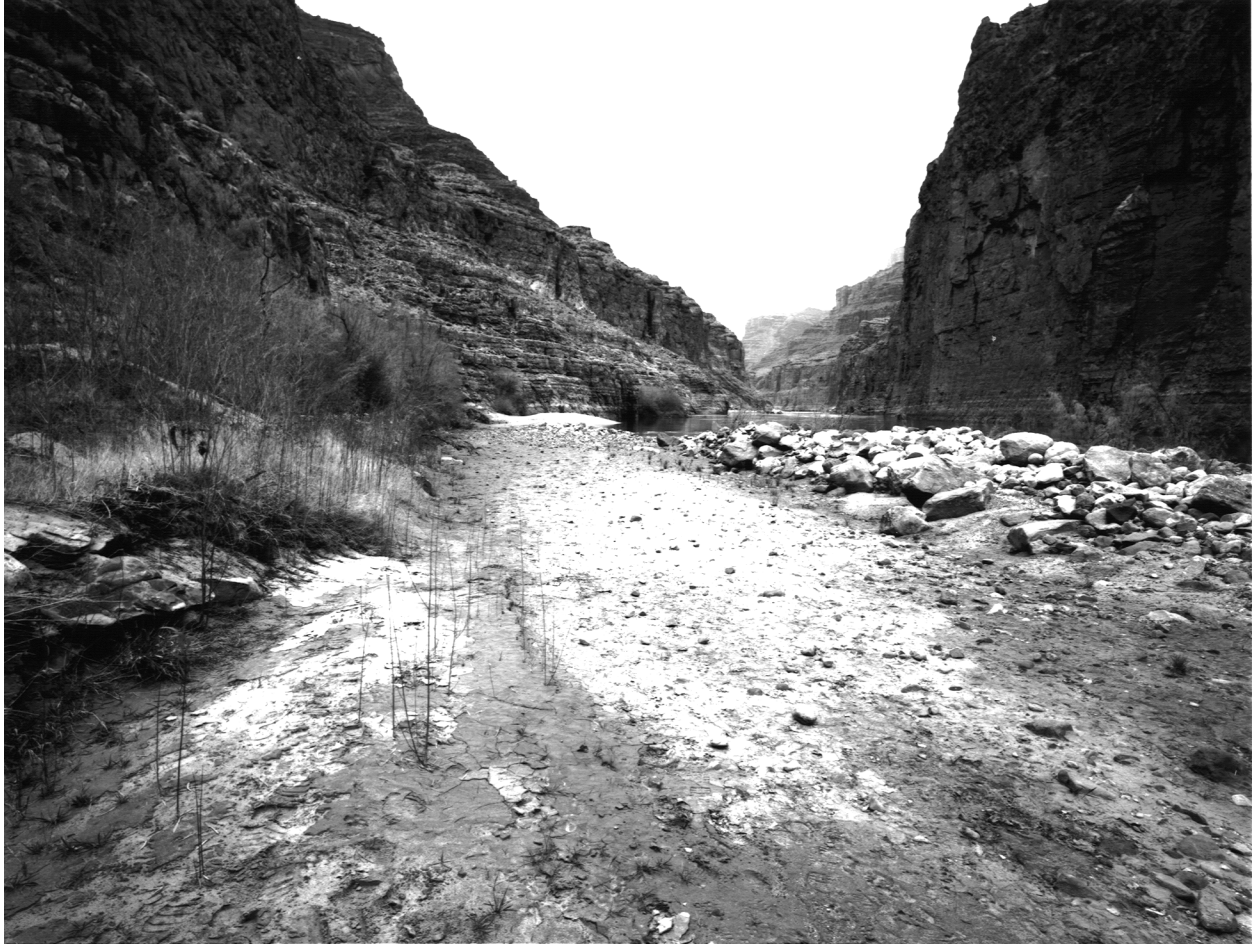
Figure 4. Continued.

B. Replicate view taken on January 2, 1992 by Jim Hasbargen. Several debris flows have aggraded the debris fan, including a large one that deposited the prominent levee at right between 1940 and 1965.
